# Air Monitoring Summary Tables

**From:** 12/16/21 12:00 am **To:** 12/16/21 11:59 pm

## Period H<sub>2</sub>S Monitoring Hydrogen Sulfide Offsite Monitors

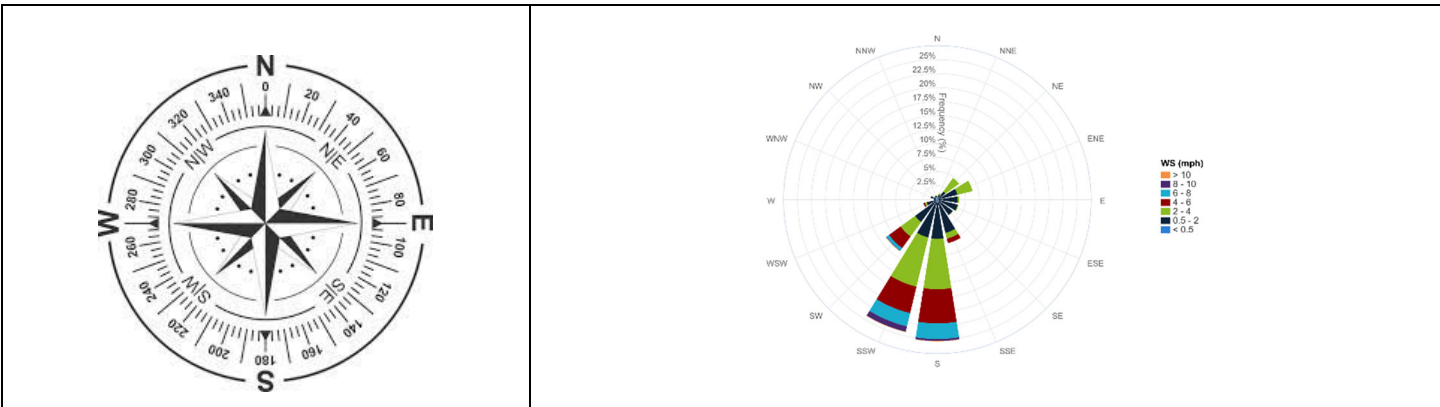
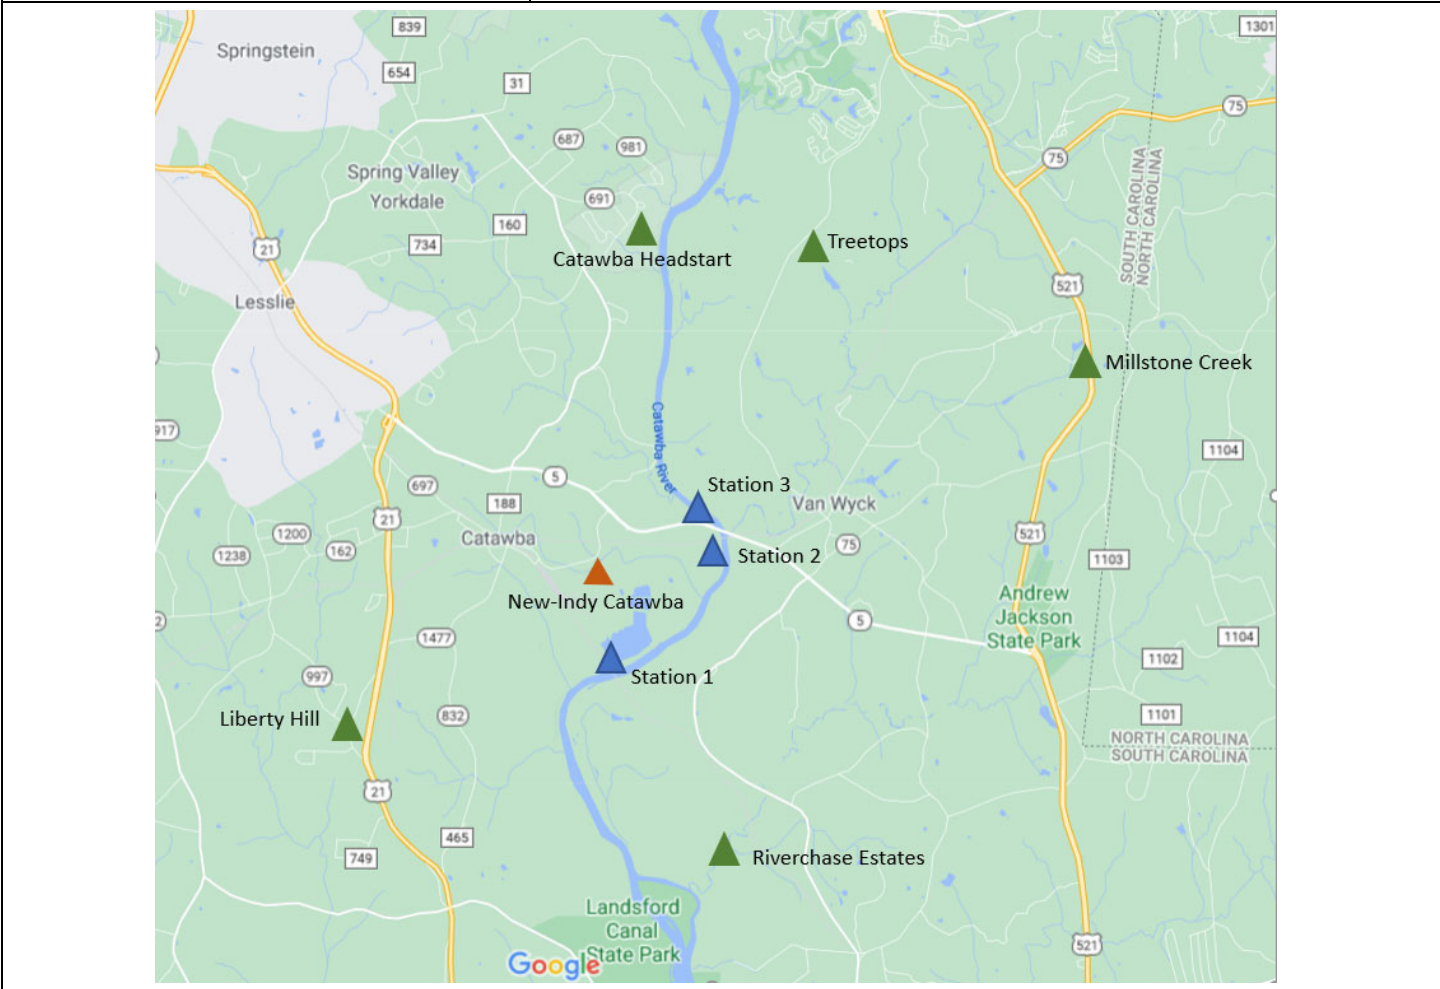
**Wind rose – Shows the direction the wind is coming from, the monitoring station being at the center of the rose.**

See wind rose diagram with aerial map figure for full wind data during this reporting period.

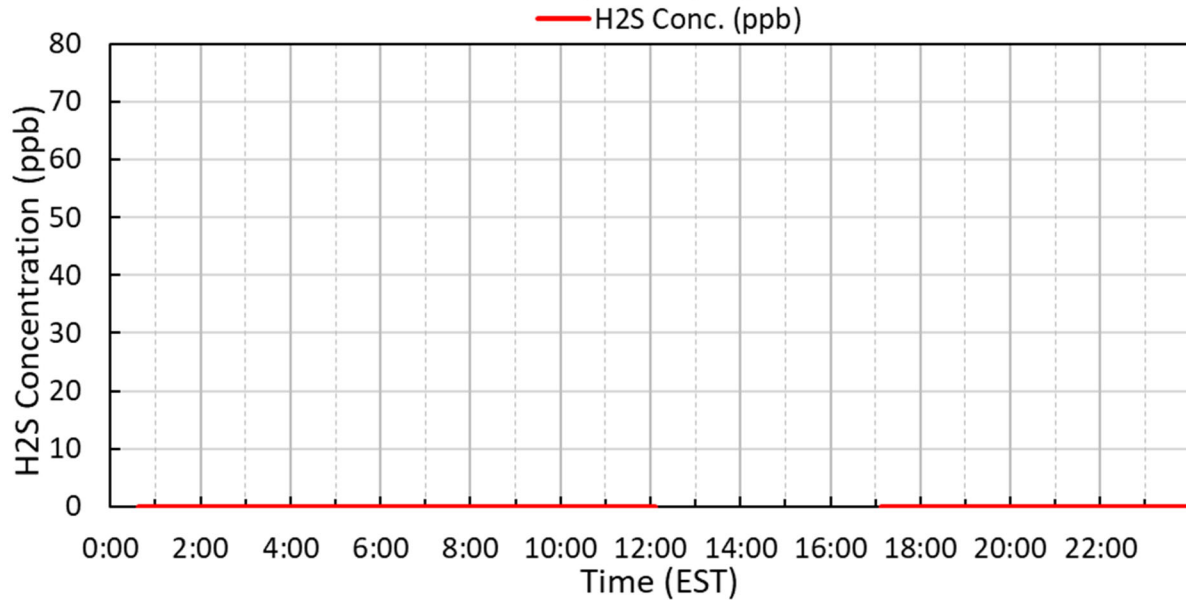
### Treetops - 12/16/2021

Below are graphs for offsite locations where hydrogen sulfide (H<sub>2</sub>S) was detected during the current reporting period.

Winds were from the south to south-southwest at 1 to 5 mph.

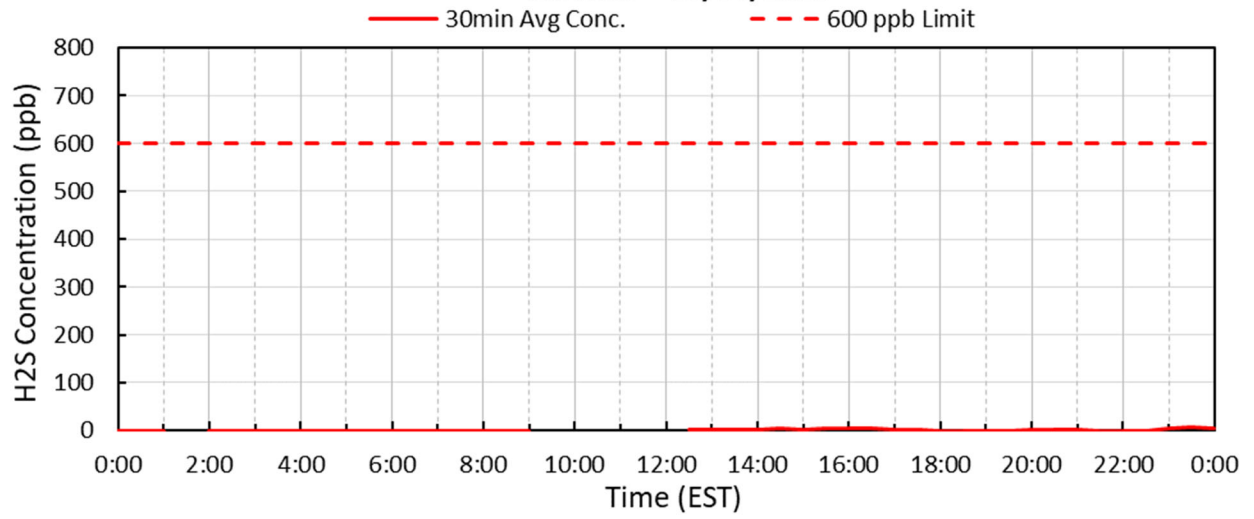
### Station3 - 12/16/2021

Below are graphs for onsite locations during the current reporting period.

Depending on wind direction, the H<sub>2</sub>S measured at the onsite fence line locations may not exit mill property at reported concentrations. Wind directions from offsite locations, blowing onto mill property, will disperse ambient concentrations to lower levels prior to exiting the plant site.
