Air Monitoring Summary Tables

New-Indy Catawba

Period H₂S Monitoring Hydrogen Sulfide Offsite Monitors

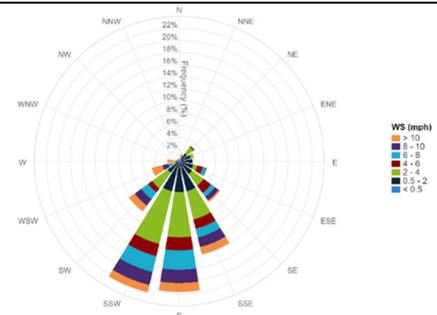
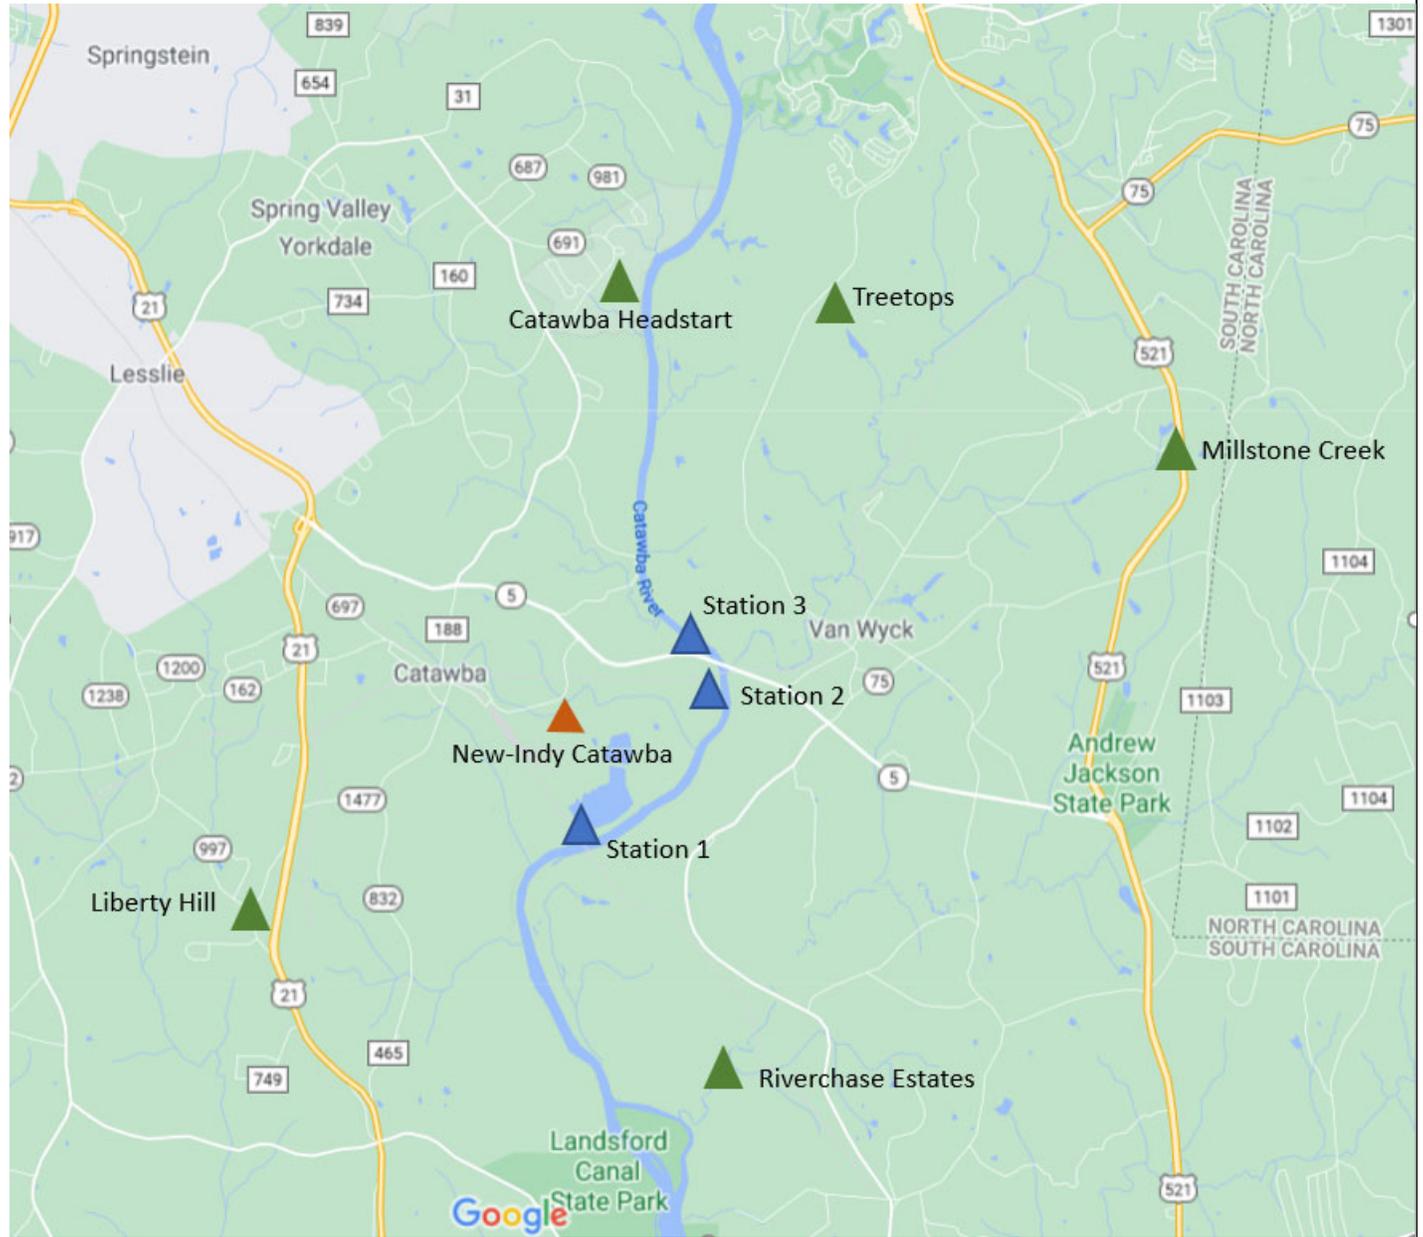
Wind rose – Shows the direction the wind is coming from, the monitoring station being at the center of the rose.

See wind rose diagram with aerial map figure for full wind data during this reporting period.

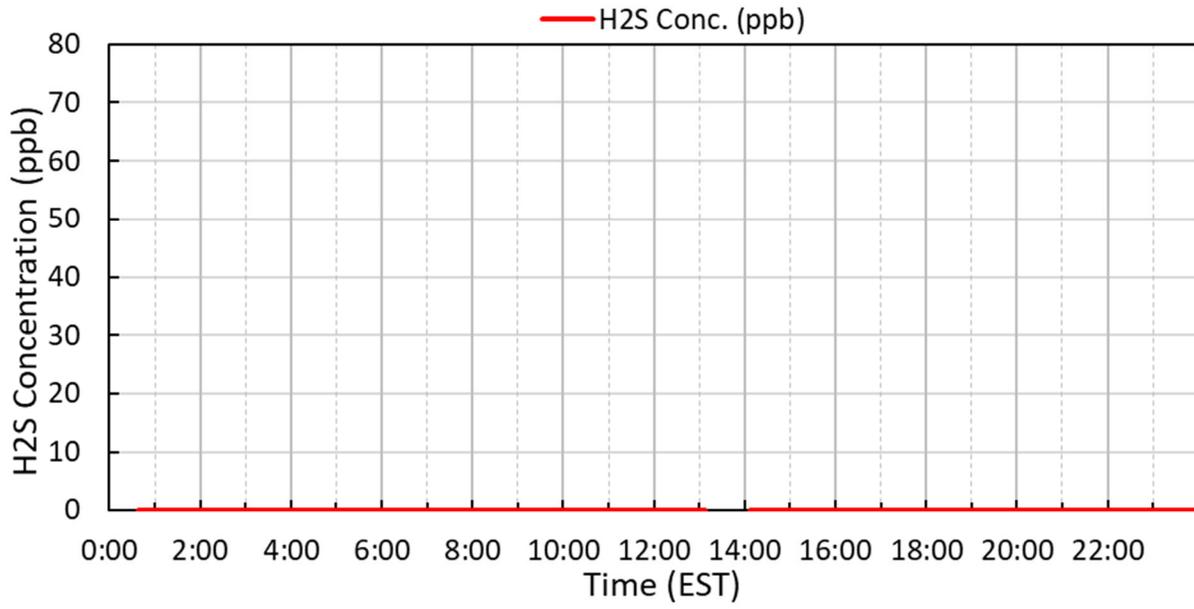
Treetops - 1/6/2022

Below are graphs for offsite locations where hydrogen sulfide (H₂S) was detected during the current reporting period.

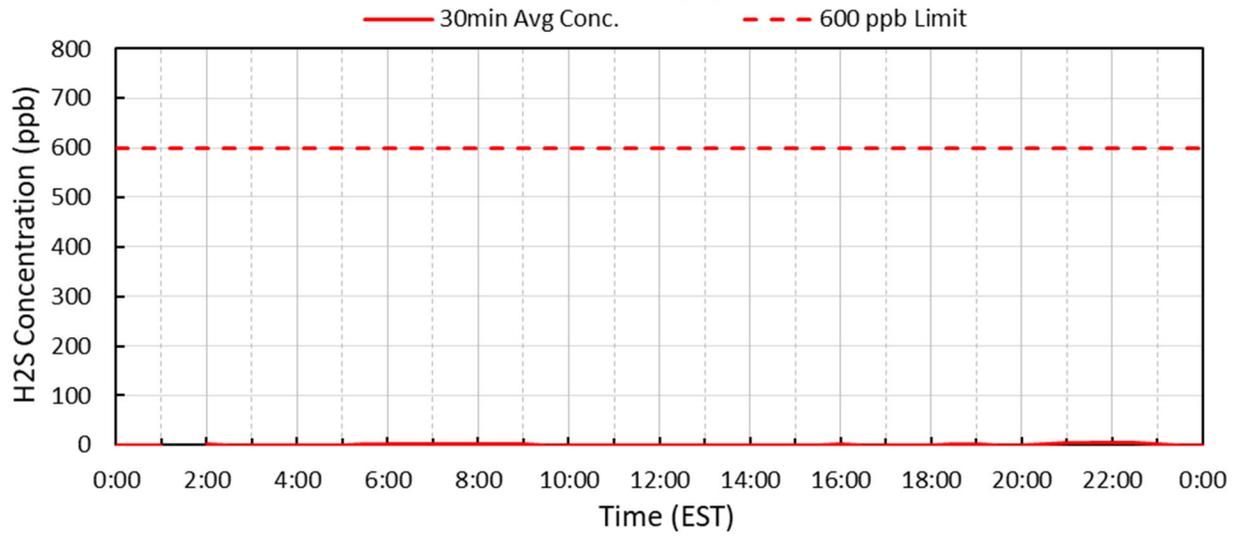
Station3 - 1/6/2022

Below are graphs for onsite locations during the current reporting period.

Depending on wind direction, the H₂S measured at the onsite fence line locations may not exit mill property at reported concentrations. Wind directions from offsite locations, blowing onto mill property, will disperse ambient concentrations to lower levels prior to exiting the plant site.
