# Air Monitoring Summary Tables

**From:** 6/06/22 12:00 am

**To:** 6/06/22 11:59 pm

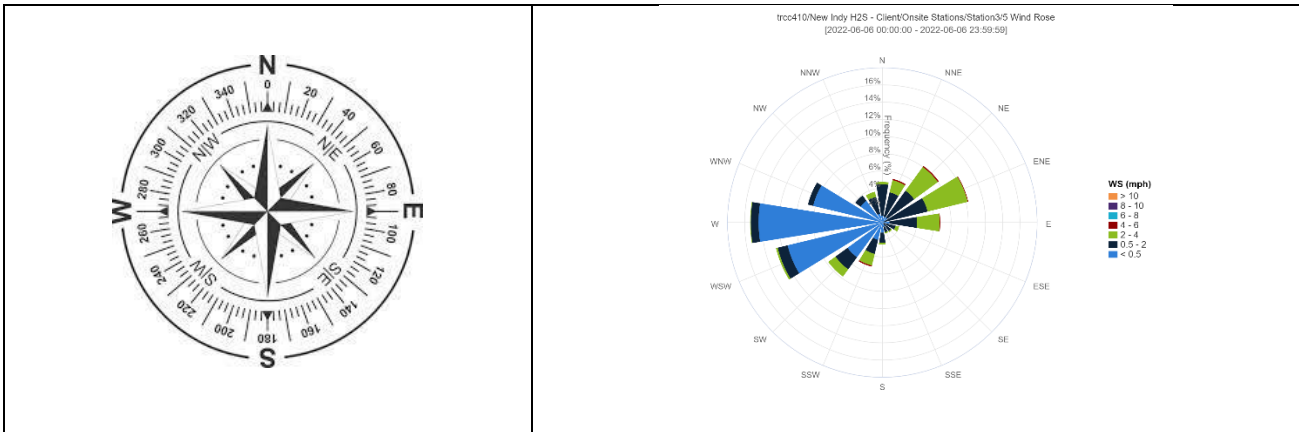
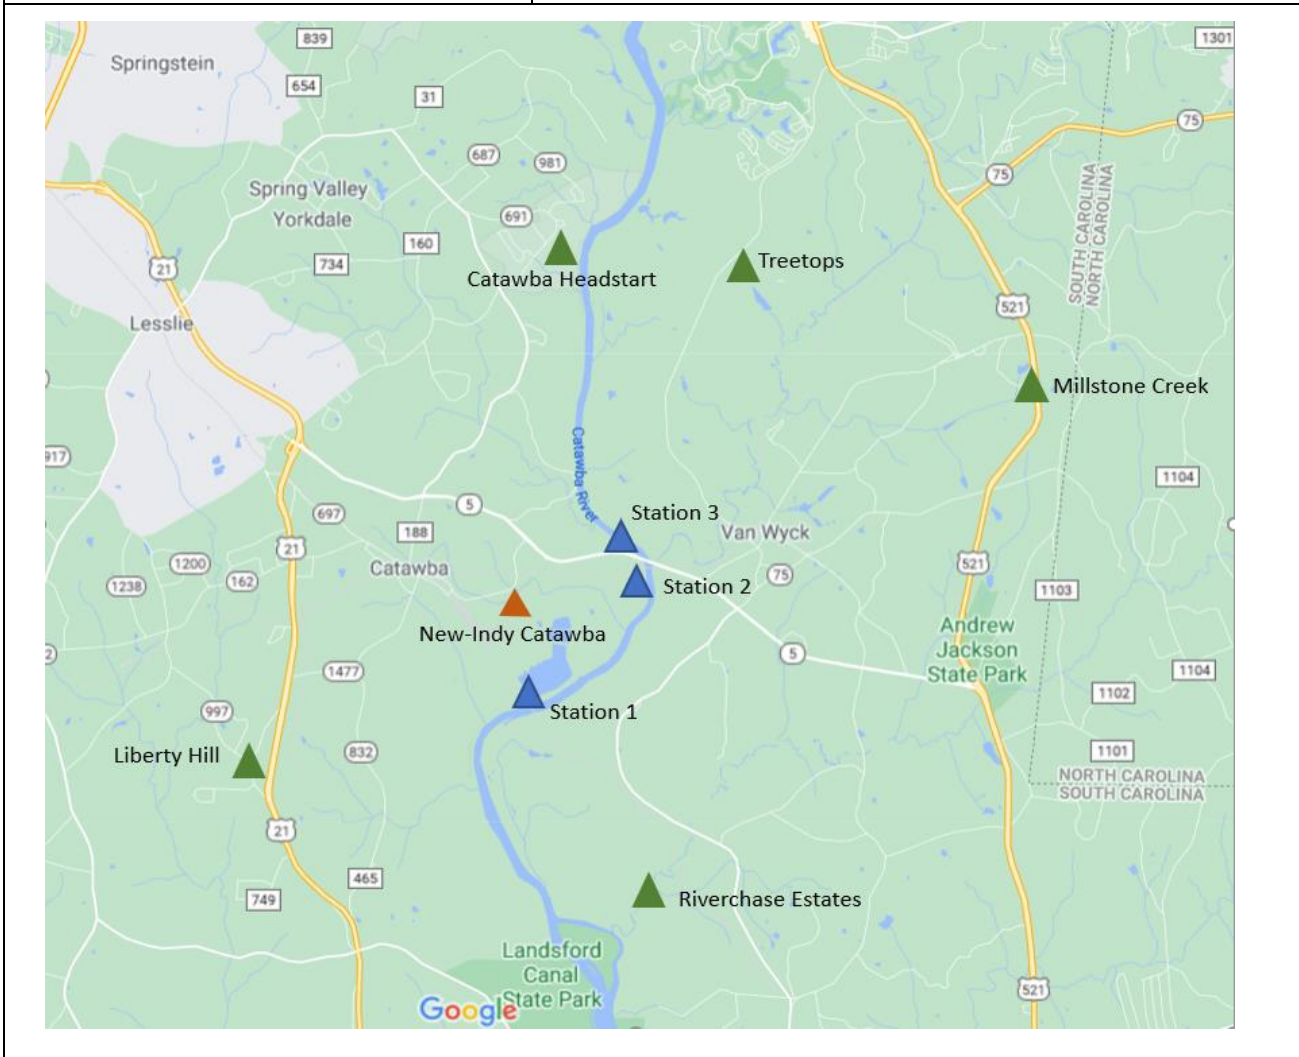
Station 3 wind rose.

Wind rose – Shows the direction the wind is coming from, the monitoring station being at the center of the rose.

See wind rose diagram with aerial map figure for full wind data during this reporting period.

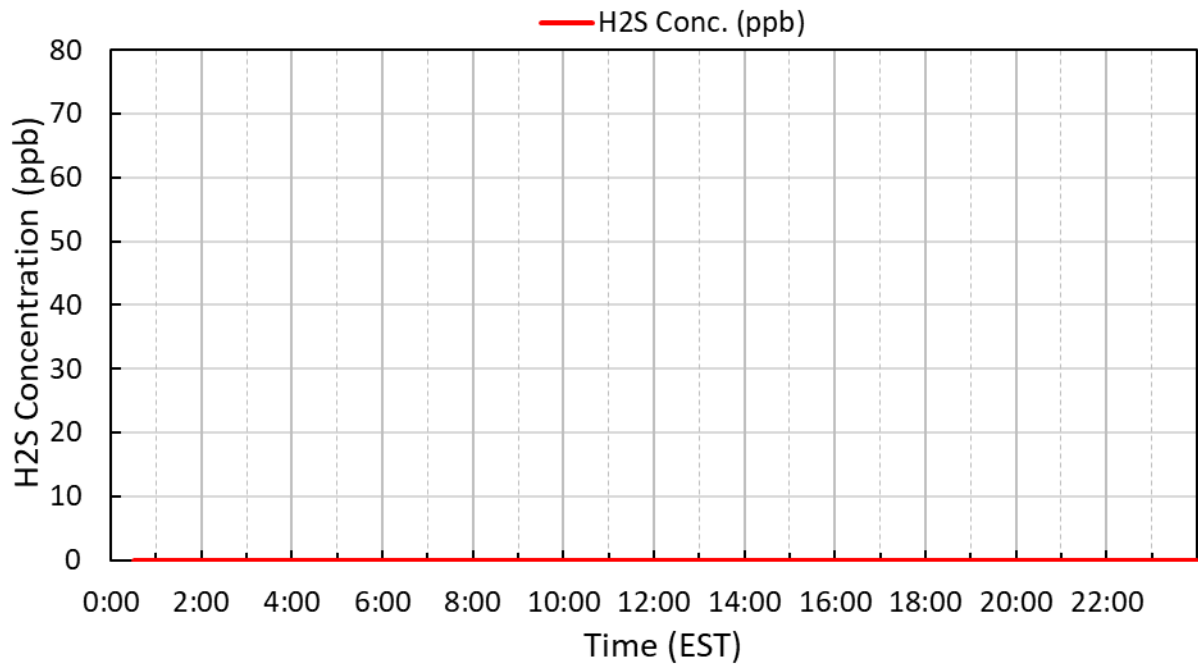
### Treetops - 6/6/2022

Below are graphs for offsite locations where hydrogen sulfide (H<sub>2</sub>S) was detected during the current reporting period.

Winds were coming from the west and the east-northeast at 0 to 2 mph.

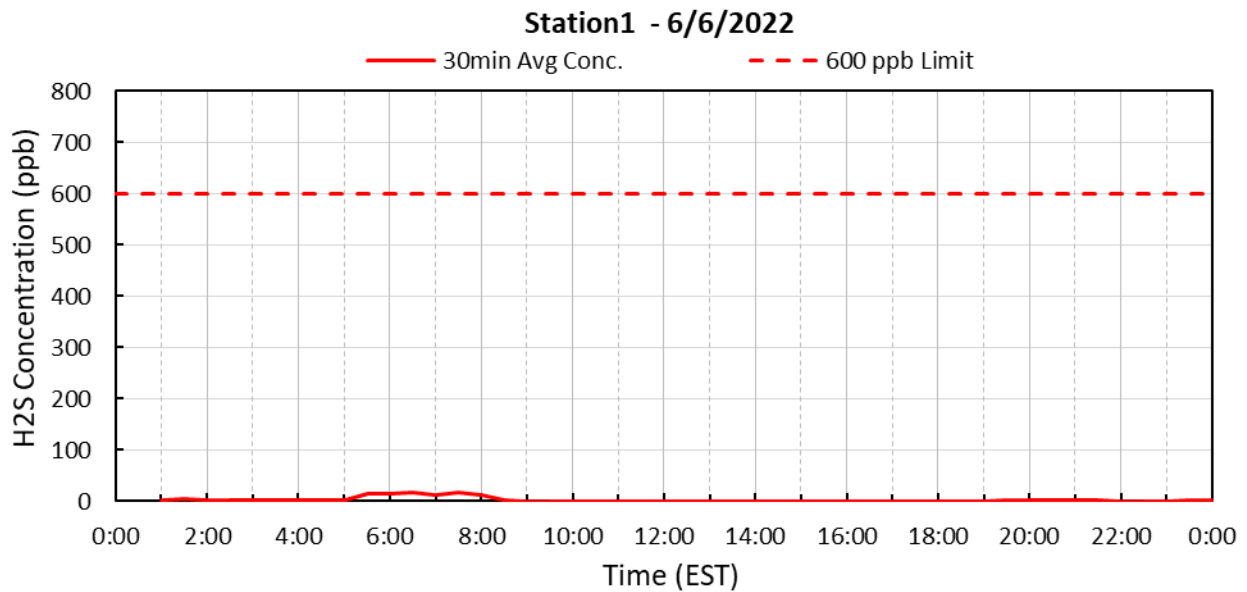
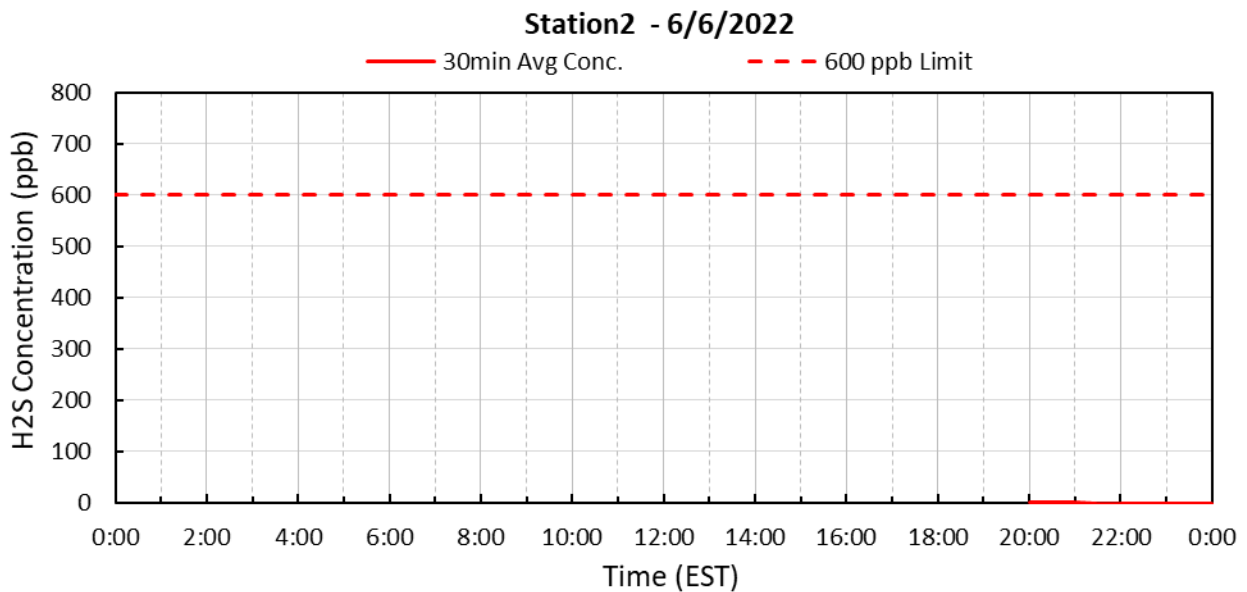
Below are graphs for onsite locations during the current reporting period.

Depending on wind direction, the H<sub>2</sub>S measured at the onsite fence line locations may not exit the mill property at reported concentrations. Wind directions from offsite locations, blowing onto mill property, will disperse ambient concentrations to lower levels prior to exiting the plant site.
