Air Monitoring Summary Tables

Period H₂S Monitoring Hydrogen Sulfide Offsite Monitors

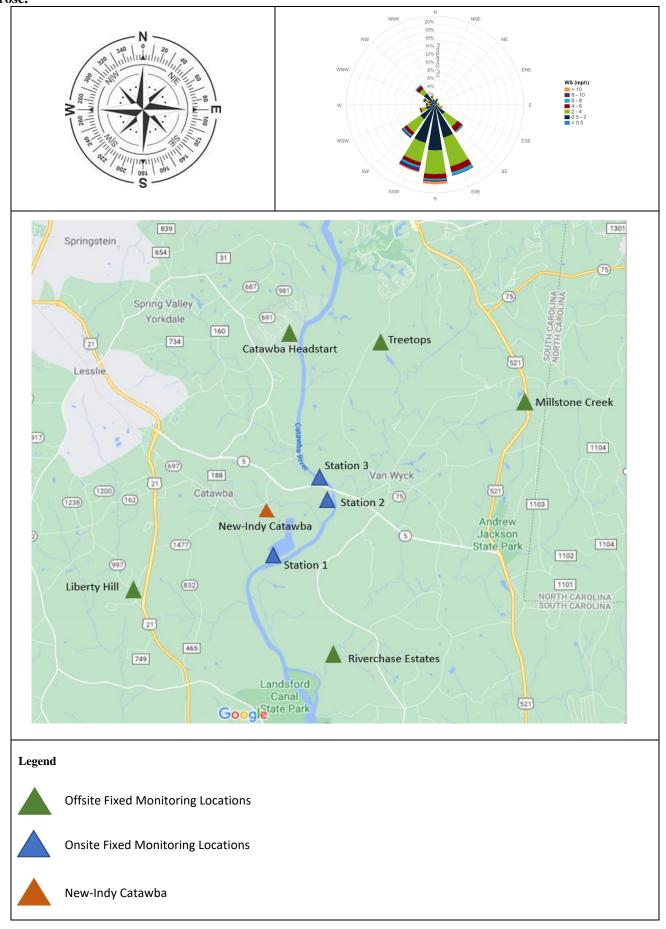
Station 1 Wind Rose – Shows the direction the wind is coming from, the monitoring station being at the center of the rose.

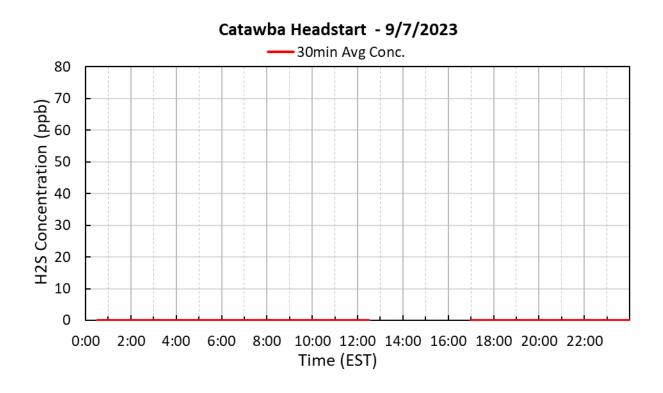
Below are graphs for offsite locations where hydrogen sulfide (H₂S) was detected during the current reporting period.

Winds were coming from variable directions throughout the day at 1 to 9 mph.

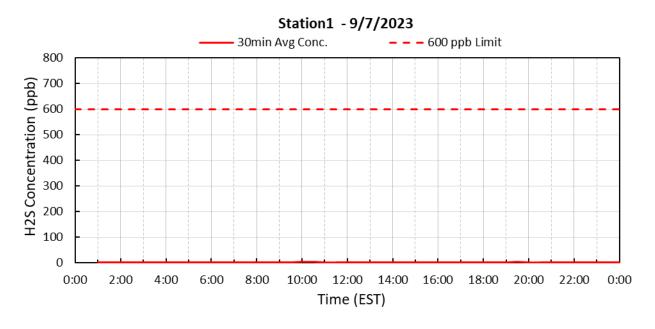
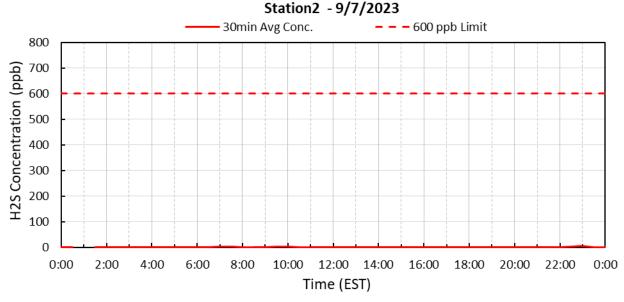
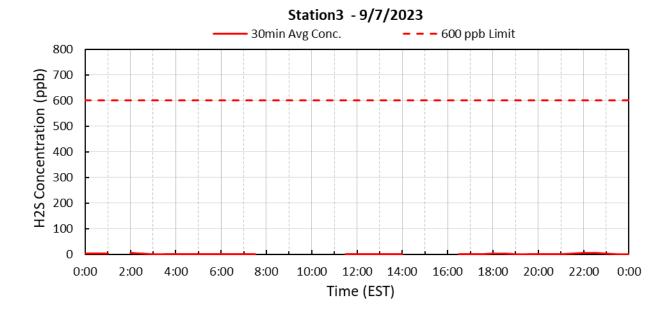
Below are graphs for onsite locations during the current reporting period.

Depending on wind direction, the H₂S measured at the onsite fence line locations may not exit the mill property at reported concentrations. Wind directions from offsite locations, blowing onto mill property, will disperse ambient concentrations to lower levels prior to exiting the plant site.

Winds were coming from variable directions throughout the day at 1 to 9 mph.
