### **Air Monitoring Summary Tables**

From: 11/10/23 12:00 am To: 11/10/23 11:59 pm

#### Period H<sub>2</sub>S Monitoring Hydrogen Sulfide Offsite Monitors

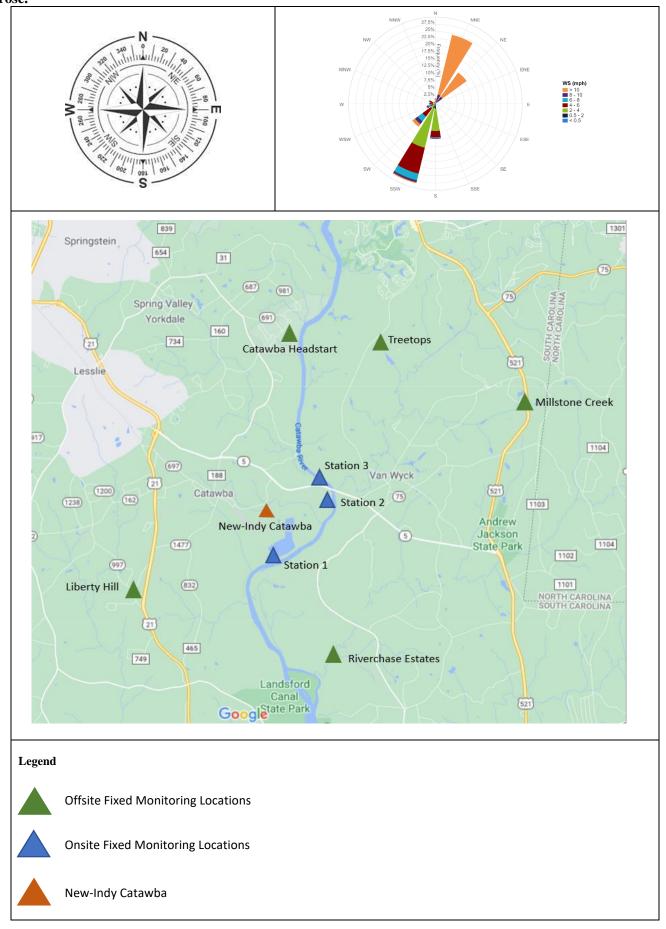
Station 1 Wind Rose – Shows the direction the wind is coming from, the monitoring station being at the center of the rose.

Winds were coming from a variable direction throughout the day at 2 to 16 mph.

See wind rose diagram with aerial map figure for full wind data during this reporting period.

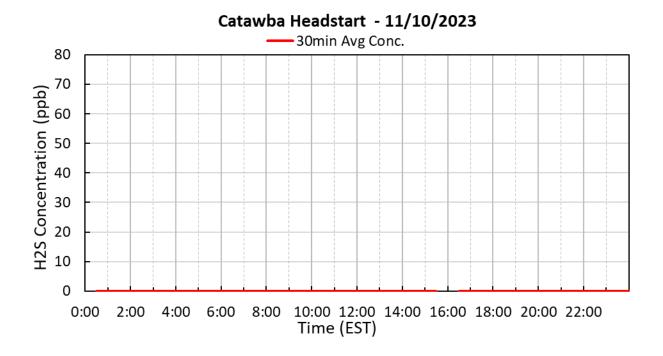
# Treetops - 11/10/2023

Below are graphs for offsite locations where hydrogen sulfide (H<sub>2</sub>S) was detected during the current reporting period.

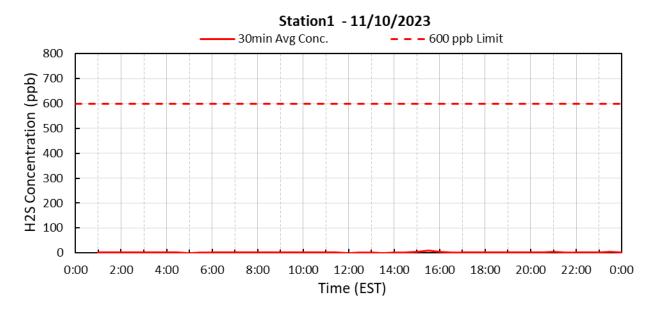
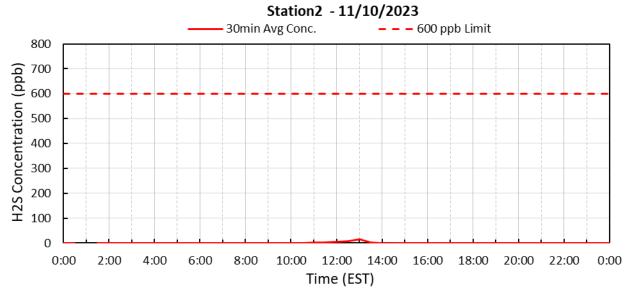
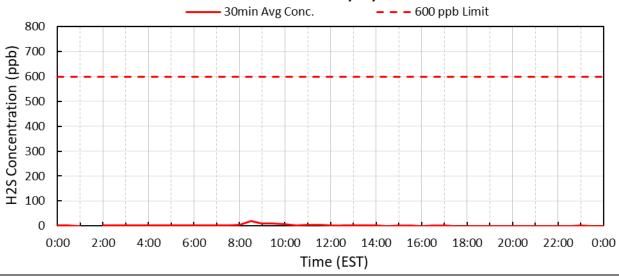
Below are graphs for onsite locations during the current reporting period.

Depending on wind direction, the H<sub>2</sub>S measured at the onsite fence line locations may not exit the mill property at reported concentrations. Wind directions from offsite locations, blowing onto mill property, will disperse ambient concentrations to lower levels prior to exiting the plant site.
