Air Monitoring Summary Tables

Period H₂S Monitoring Hydrogen Sulfide Offsite Monitors

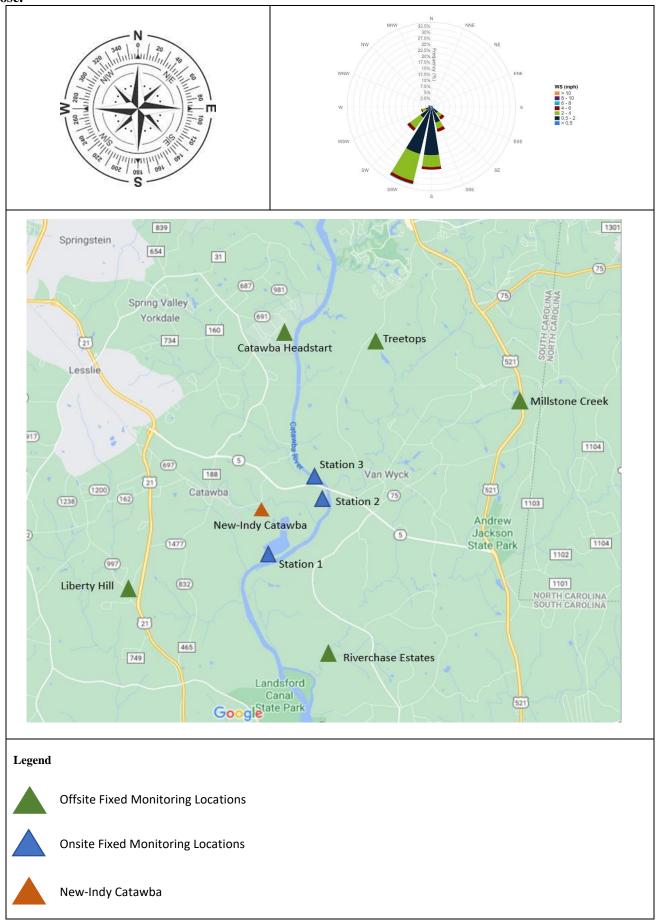
Station 1 Wind Rose – Shows the direction the wind is coming from, the monitoring station being at the center of the rose.

See wind rose diagram with aerial map figure for full wind data during this reporting period.

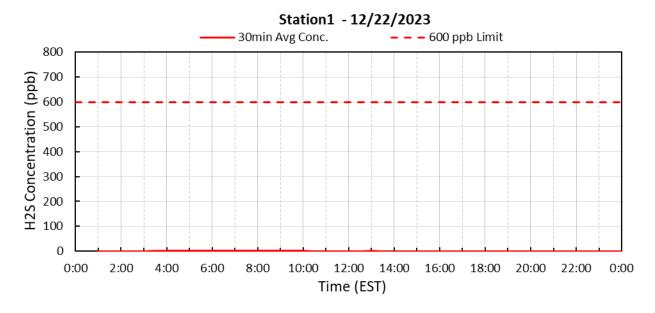
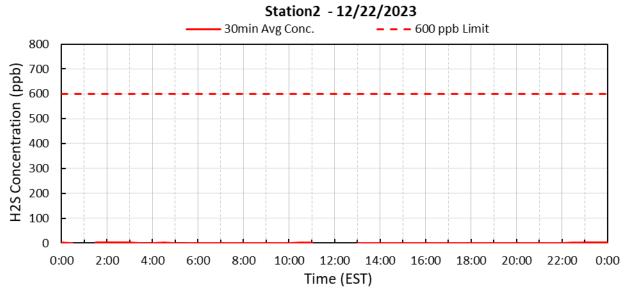
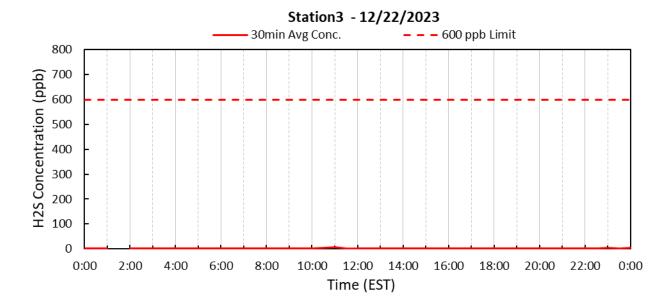
Below are graphs for onsite locations during the current reporting period.

Depending on wind direction, the H_2S measured at the onsite fence line locations may not exit the mill property at reported concentrations. Wind directions from offsite locations, blowing onto mill property, will disperse ambient concentrations to lower levels prior to exiting the plant site.

Winds were predominantly coming from the southwest, south-southwest, south and south-southeast direction throughout the day at 1 to 5 mph.
